RUPTURE OF THE GIRTH GEAR / KILN SHELL CONNECTION AT AN EXPANDED CLAY FACTORY

ABSTRACT

KEYWORDS: rotary kiln; fatigue failure; spring plate; eyebar; fatigue class (FAT)

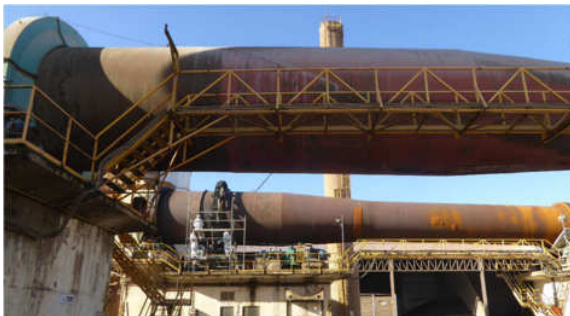
Figure 1 – Partial view of the kiln that suffered the failures, in the background. In the foreground, another kiln decommissioned since 2011.

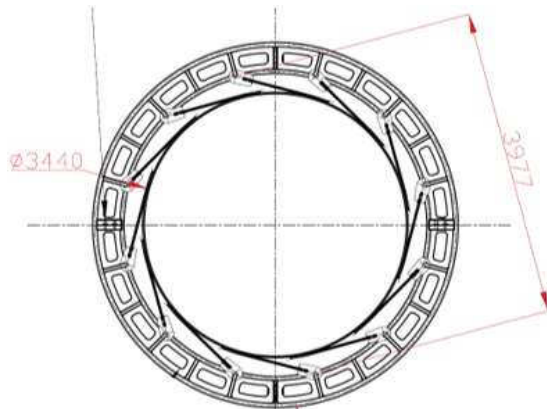
Figure 2 – Schematic representation of the toothed crown and the 12 spring plates.

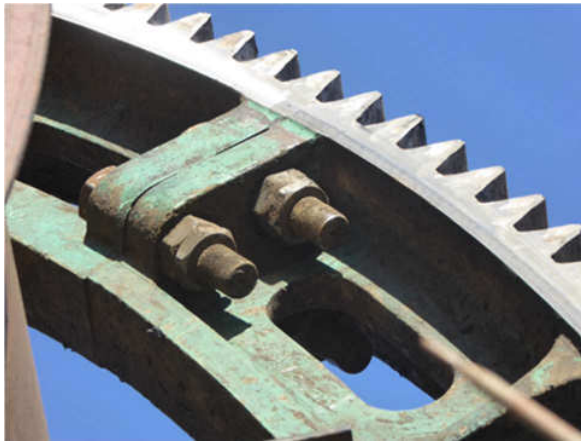
Figure 3 – Toothed crown (girth gear), composed of two halves; detail showing one of two connections.

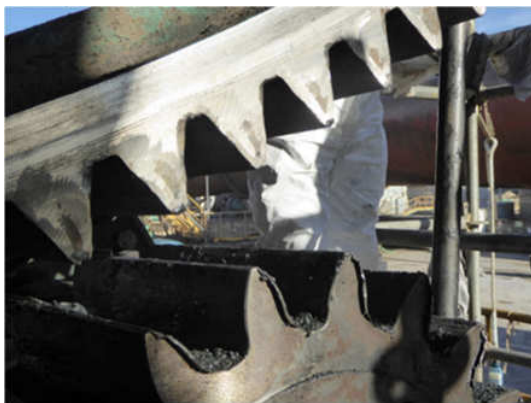
Figure 4 - Toothed crown and pinion. The teeth of the pinion show plastic flow of material outside the teeth width; at a lower scale this also existed in the toothed crown but that plastically deformed material was removed during the present stoppage.

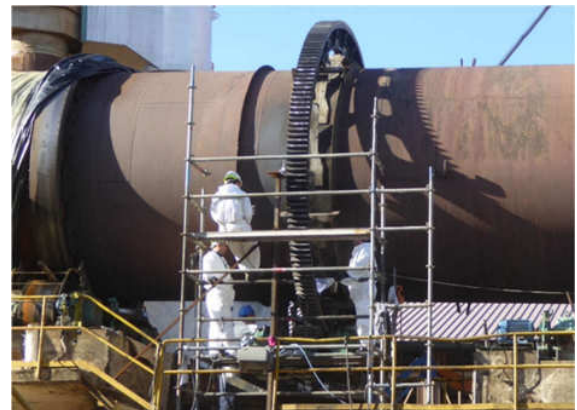
Figure 6 – Spring plates. a) Zoom of Figure 1, showing the toothed crown and spring plates (identified with arrows), undergoing repair/assembly work by technical staff.

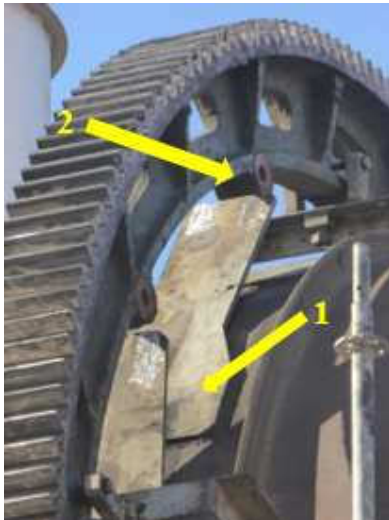
Figure 6 – Spring plates. b) Spring plate (arrow 1) connected to the kiln, but not yet connected to the toothed crown pins (the location of the pins is shown with arrow 2).

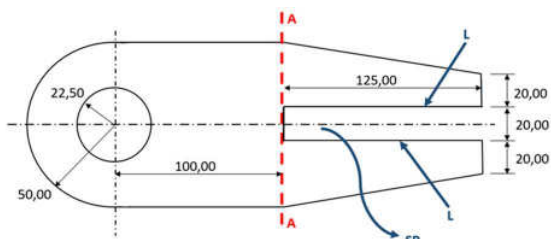
Figure 7 – Sketch of an eyebar for connecting the spring plate to the toothed crown pin. Each spring plate has two such eyebars, fillet welded along 'L' to the spring plate ('SP') that fits into the 20mm thick slot represented. The fracture of these auxiliary plates occurred always along the path schematically indicated by the interrupted line 'AA'.

On December 18, 2019 it was found that 10 spring plates suffered complete rupture, always occurring in the welded auxiliary plates (eyebars) just mentioned, implying that 20 eyebars were found broken. The rupture was of similar nature on the broken eyebars: cracks developed along the path represented by the interrupted line 'AA' of Figure 7.

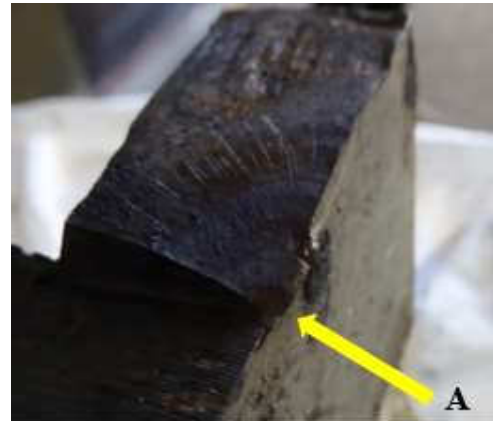
Figure 8 gives one example illustrating the behaviour of all fractured auxiliary plates (eyebars). In this figure, the crack is a 'textbook case' of a fatigue crack initiated at corners of a rectangular slot, and growing as a quarter of ellipse in each side of the rectangular slot.

b) Detail of the crack propagation, starting at corner. Figure 8 – Crack surface of one of the broken eyebars.

Although the cracks observed displayed approximately the same features, the extension of the fatigue crack region seemed not to be the same in all of them. This is consistent with a scenario where not all of them suffered rupture at the same time, but instead one suffered rupture first and its load share was then transferred to the surviving plates, and so on and so forth.

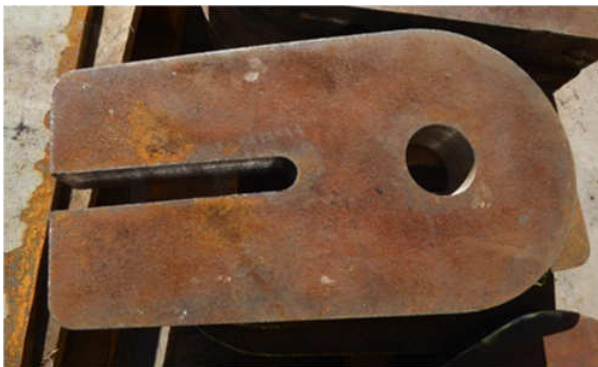
Figure 9 – New eyebars designed by Leca / Avelar

The new auxiliary plates designed by Leca / Avelar no longer display the rectangular slot, but instead they show a semi-circular slot, see Figure 9. This will dramatically reduce the stress concentration effect implied in the previous failed design, improving the fatigue life of this connection
