Adhesive bonding of the ceramic claddings in the facades of residential buildings

Slawomir Czarnecki, Jerzy Hola, Lukasz Sadowski

Wrocław University of Science and Technology, Wybrzeże Wyspiańskiego 27, 50-370 Wrocław

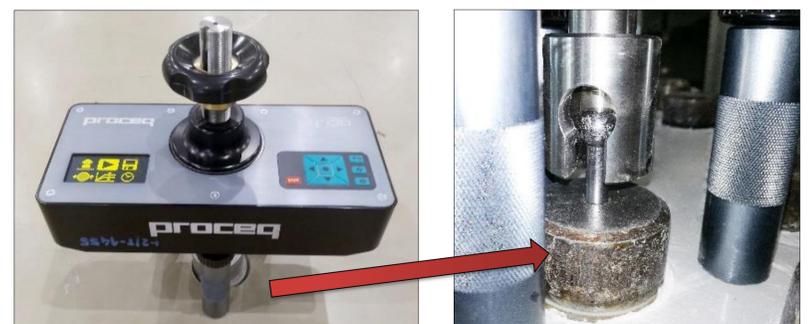
Figure 2. The view of: a) pull-off tests apparatus, b) steel disc glued to the surface

According to the standard to achieve meaningful results it was necessary to obtain the samples of the size that allows to place the edge of the disc a minimum of 50mm from the edge of the specimen. After drilling, the surface of the discs was vacuumed and cleaned with acetone without compromising the integrity of the cladding. Then the steel discs (cleaned with acetone) were glued using Poxipol two-component adhesive agent. The glue was applied to the surface of the puck and the surface of the sample. The apparatus was levelled and programmed to complete the test in a maximum of 100 seconds at a loading rate of 0.05 MPa/sec. The result of the test is recorded on the instrument along with a graph of load increase over time. After entering the relevant data into the apparatus, the pull-off strength was automatically calculated.

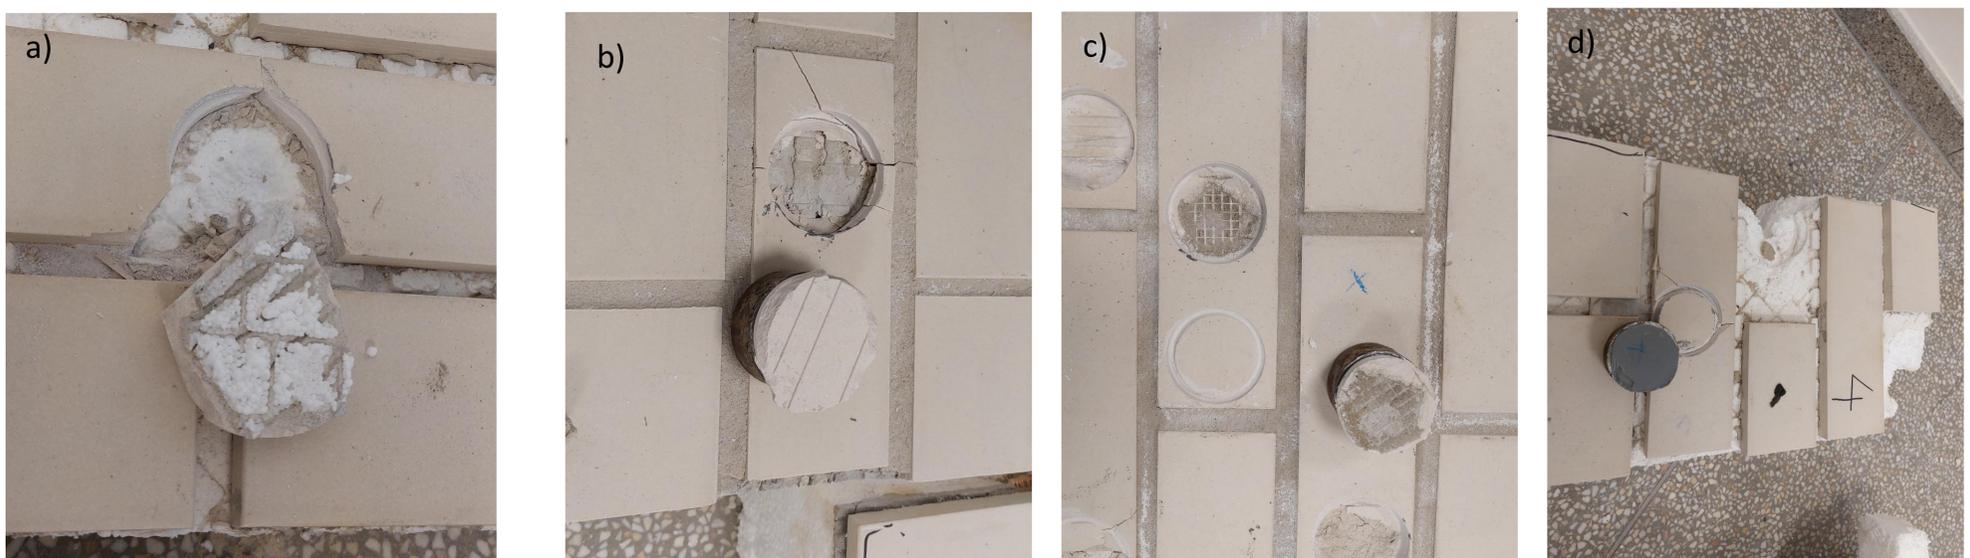
Figure 3. The view of: a) cohesive failure model in the insulation, b) adhesive failure model between the cladding and the glue, c) cohesive failure model inside the glued layer, d) adhesive failure between the steel disc and the cladding

Analysing exemplary results presented in figure 3a and 3c it can be seen that the model of failure is cohesive in „the weakest” material tested. This type of failure is the most expected and during the tests was also characterized with the highest value of pull-off strength that was approximately 0.6 MPa. In the contrary the least wanted model of failure is adhesive between the cladding and the glue, presented in figure 3b. That may be a results of not sufficient preparation or not following the all necessary guidelines of the standards. It was also proved by the lowest values obtained during pull-off tests that were lower than 0.1 MPa and are not acceptable to obtain in such structures.
